Manhole Inspection Summary

Manhole # S29EE1008MH

Insp Date: **12/21/06 10:33 AM**

Location Address: **3910 KESWICK RD**

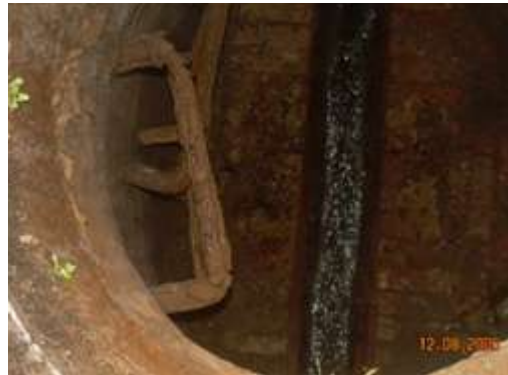
Top View

Corroded steps. Bench debris.

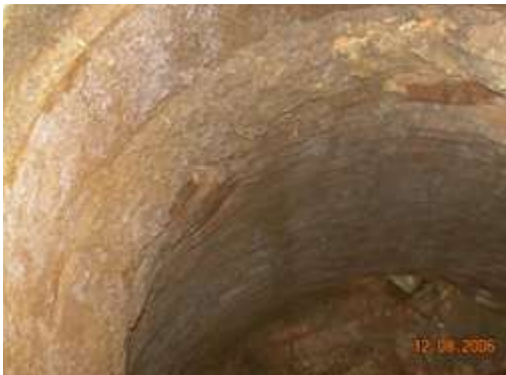
Defect

Frame leaks. Frame offset. Adjustment, Corbel and Barrel infiltration.

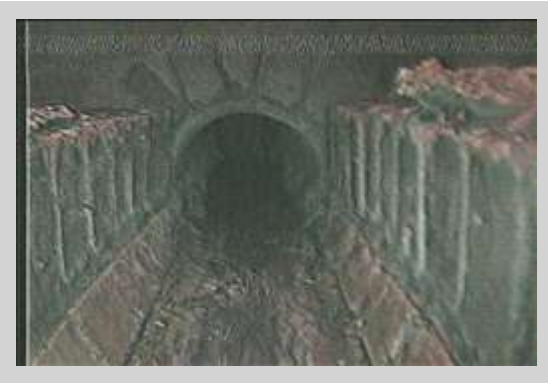
8 in. Circular Gravity Sewer Pipe Out @ 12 O'Clock

Channel deterioration.

Infiltration: **Evidence** Pipe Seal Cond: **Cracked**

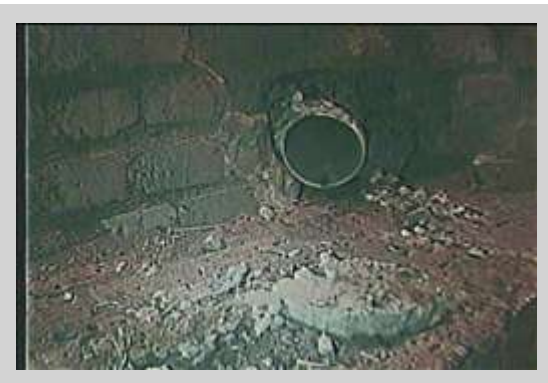
4 in. Circular Gravity Sewer Pipe In @ 5 O'Clock

Infiltration: **Evidence** Pipe Seal Cond: **Cracked**

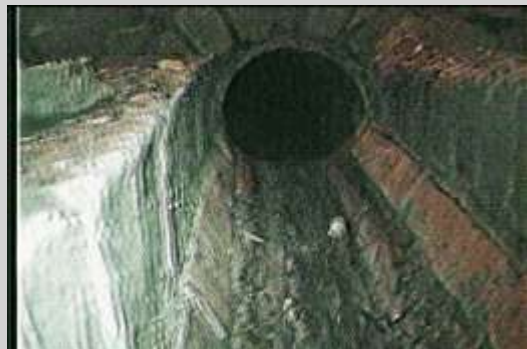
8 in. Circular Gravity Sewer

Infiltration: **Evidence**

Pipe Seal Cond: **Broken**
